## Early 19th Century London Gaming Room

Some notes on two English, Sienna marble chimney-pieces in the French Italian manner, dating to 1827, from the First Floor main room of a large London gaming house.

Research Report  
January 2015

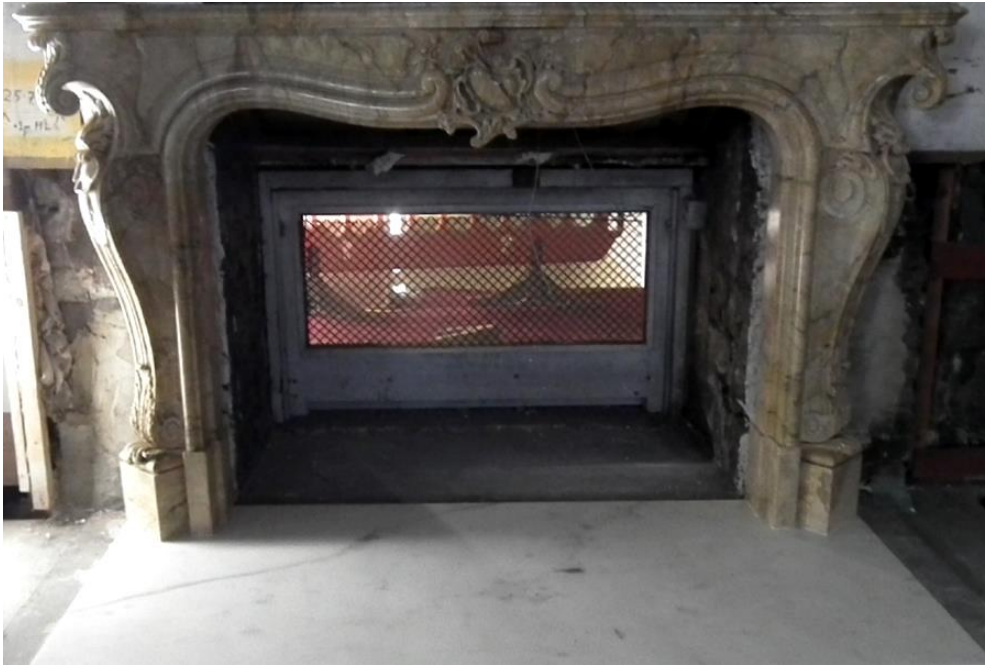
*Plate 1: The Italian, Sienna marble chimney-piece on the 1st floor, prior to restoration and re-fitting onto a new Statuary marble slab.*

The decision to remove, for cleaning and restoration, a pair of Sienna marble chimney-pieces carved for the principal front room of a late 1820s London Club, has brought to light a number of features which provide an indication of the complexities of carving large sections of Sienna marble in early 19th century London.

Prior to restoration it was apparent that the nature of the Sienna marble and the availability of such large blocks, with good even veining and few vents, had been a governing feature of their production. The evidence for this could be seen on the chimney-piece from the North West side of the room, where the right hand side of the cornice had been extended, as detailed on the image on **Plate 8**. The extension at the top of the cornice on the right hand side would have been clearly visible to anyone warming themselves by the fire and the addition of an extension can only have resulted from either the block being not long enough or perhaps there may have been a large area of either weakness, faults or uneven colouring. Such is the rarity of finding large, evenly colour and un-fractured blocks of Sienna marble that it is remarkable that the cornice of the chimney-piece in the Southern end of the room did not require a similar extension.

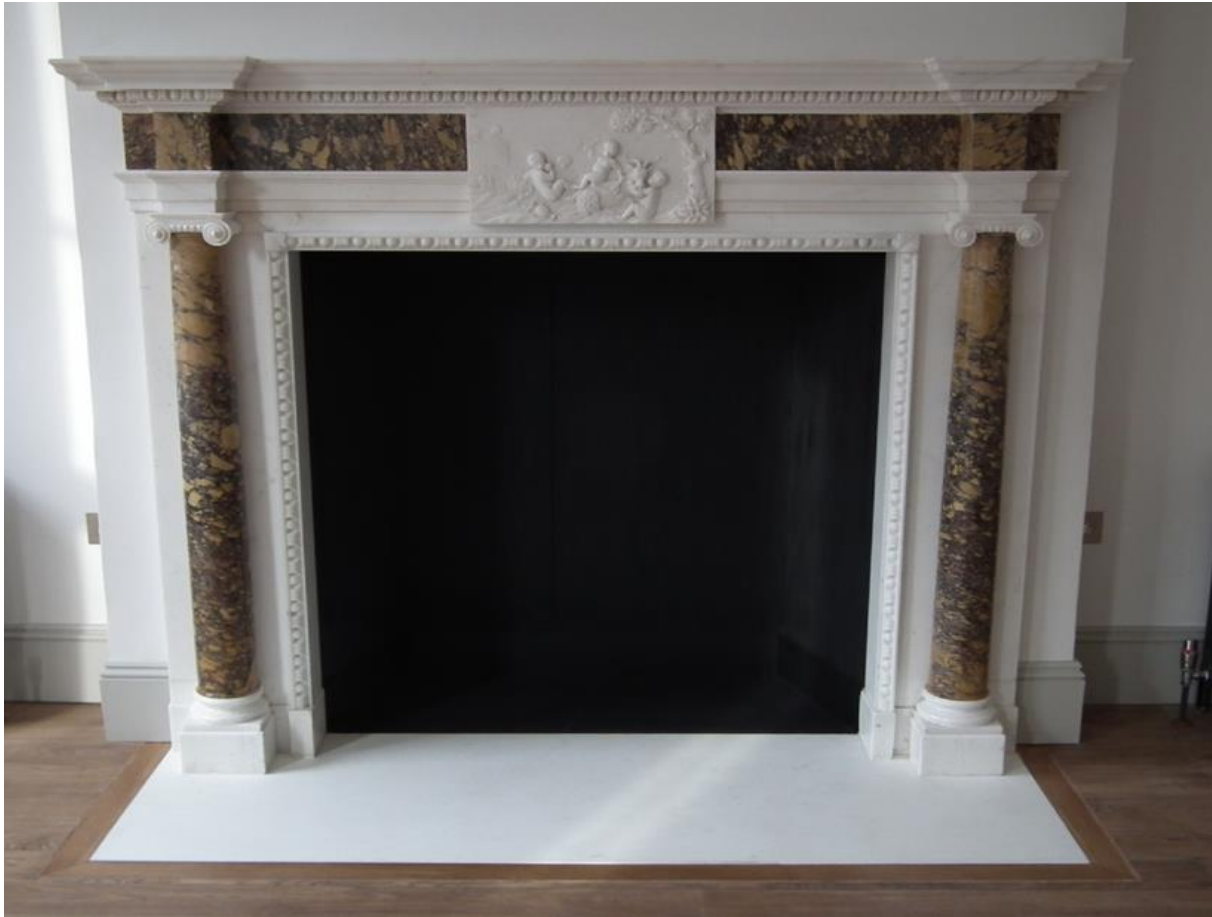
Plate 2: Detail of a late 18th century statuary and Sienna marble chimney-piece, illustrating the decorative nature of the combination of Sienna and Statuary marbles, that was in fashion from the 1730s through to the end of the Georgian era.

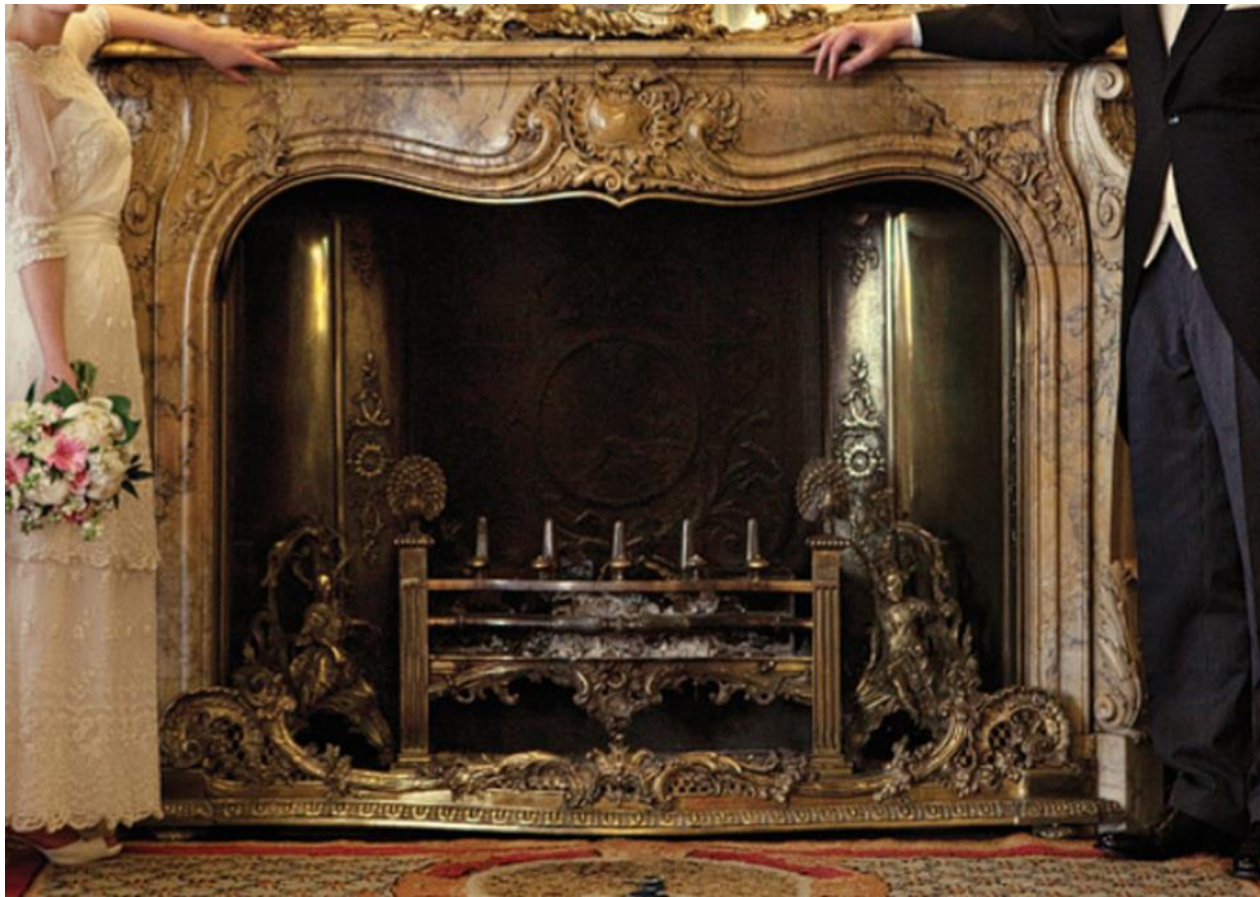
Plate 3: The Sienna marble chimney-piece in the Elizabeth Salon at Belvoir Castle. The Louis XIV style interior was designed by Elizabeth Duchess of Belvoir in conjunction with Benjamin Dean Wyatt in circa 1825 using elements removed from Chateau of Madame de Mainenon, possibly including this chimney-piece. (Google image sited from [trulymadlydottieblog.com](http://trulymadlydottieblog.com))

However the bulk of the Sienna used for chimney-pieces during the 18th century was veneered, a thin slice, attached usually to a stone liner by the means of shellac (as shown above where the frieze and blocking panels were all constructed from sections of veneer, only the columns being formed from solid sections). Examples of its use are extensive, such as Joseph Wilton, whose account for the provision of marble for the chimney-pieces for the building adjacent to the Strand at Somerset House, between 1779-80, records the

The reasons for this reflect a change in ornamental taste during the 1820s and of particular relevance to the two chimney-pieces discussed here, is the work undertaken at Belvoir Castle by Elizabeth, Duchess of Rutland. The architects involved in the alterations to Belvoir castle in the late 18th and early 19th century were members of the Wyatt family, James (1746-1813) and after his death Benjamin Dean Wyatt (1775-1855) and Matthew Coates Wyatt (1778-1862). The Elizabeth Saloon, created by the later in circa 1825 incorporated original elements from a “Chateau of Madame de Mainenon” including the carved and gilded panels and doorways (Hussey p137). The chimney-piece used within the room is carved from Sienna marble in the manner of Louis XV, as detailed in Plate 3.

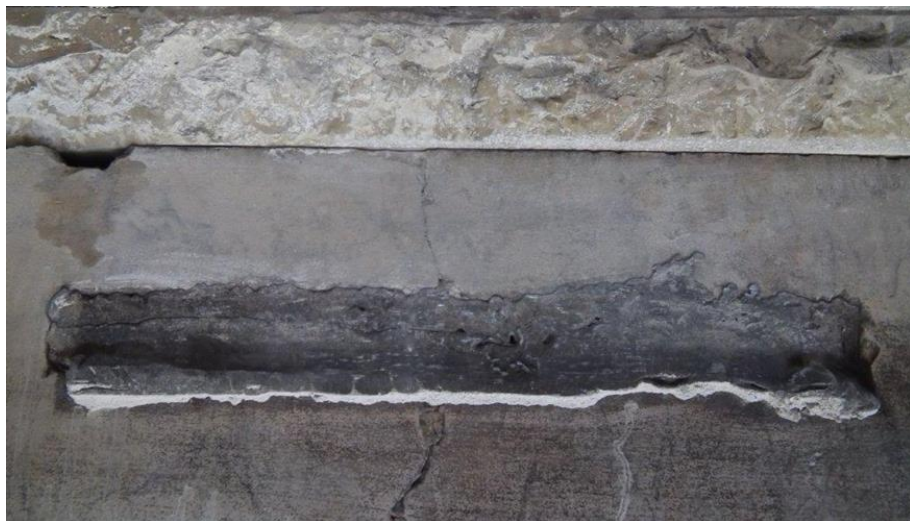
Plate 6: Detail of the back of one of the chimney-pieces, showing the wrought iron cramp which has been leaded into the back of the frieze, to prevent a natural fracture line present, moving or separating. Numerous such cramps were required to re-enforce both the back of the frieze and underside of the shelf or cornice sections of both chimney-pieces.

It would be presumptuous for us to assume that all of the work illustrated in Plates 6 to 11 was definitely effected when the chimney-pieces were made, for some could be later repair work resulting from mechanical damage. However the nature of the material and the high quality of the masonry work required to effect the bulk of the repair work is to such a high standard that it can be seen to indicate that much of this work was done before the chimney-pieces were installed. One element is probably not contemporary; for on one of the friezes one of the acanthus leaves to the centre of the frieze has been replaced in composition. This is almost certainly a later repair, and has been retained as the recess cut into the main body of the frieze, indicates how repair work, required and effected at the time of construction, was secured by letting lugs into recesses cut into the main body.

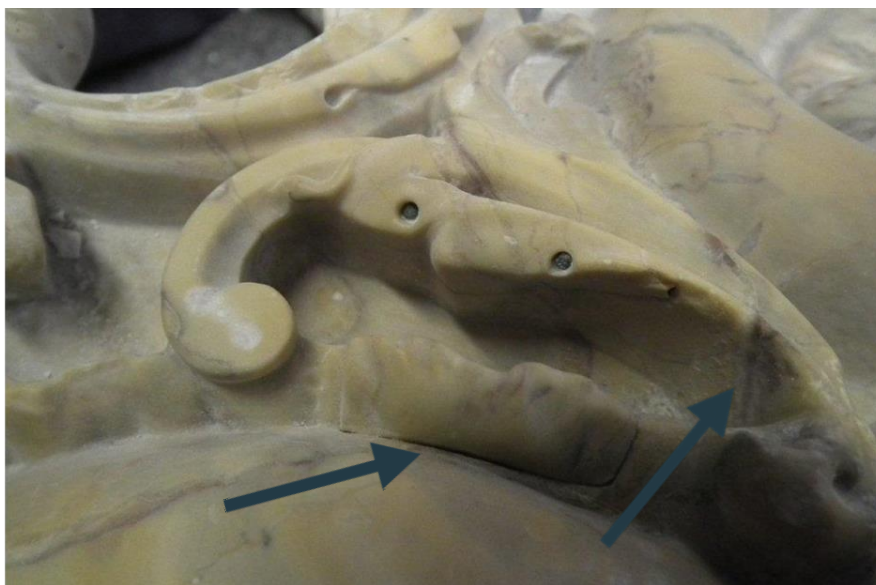
Plate 7: Detail showing two of the pins and a third hole, used to secure a replacement section of Sienna marble set into the frieze section of one of the chimney-pieces. The joint line for part of the repair has been highlighted with arrows.

Whilst restoration work was in progress, a detailed examination of the problems of manufacturing chimney-pieces from Sienna marble became clear. Large blocks of Sienna marble, with even colouring and striations have always been difficult to locate, even in the 18th century when the demand for the finest possible marble for chimney-pieces produced in England was enormous. This appears to have still been the case in the third decade of the 18th century when these chimney-pieces were made. For structural reasons, the main body of the frieze required cutting from a single block, but these blocks were frequently vented and substantial re-enforcements were required. During the period this re-enforcement work was commonly done by inserting iron cramps, with ‘dogged ends’, which were let into rebates carefully cut into the marble and then secured with lead, a feature illustrated in the image on Plate 6, which show cramps let into the underside of the main shelf or Cornice as well as the main body of the frieze. However even with these in place the sculptural studio ran into some difficulties when carving. This is illustrated by the centre section of the carving of one of the chimney-pieces, the cartouche to the centre and the foliage and scroll work to either side required a number of new sections of marble to be let into the marble block, a process discernible during cleaning when the pins used to secure these sections into the main block became apparent (Plate 7).

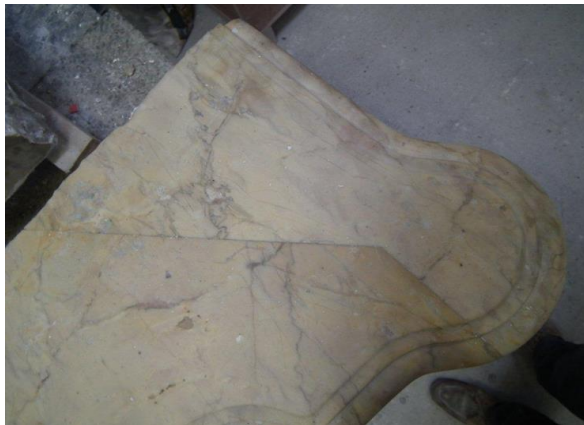
*Plate 8: Detail of the right hand end of the shelf or cornice from the chimney-piece at the Northern end. The sculptural workshop that produced the chimney-pieces were obliged in this instance to attach an extension to the right hand end, the angled lines and the variations in both the colour of the Sienna marble and the striations passing through it, being clearly visible. The reason for this was probably due to the presence of an ungainly impurity within the original marble block or perhaps more likely the block was just not quite long enough to cut a single slice.*

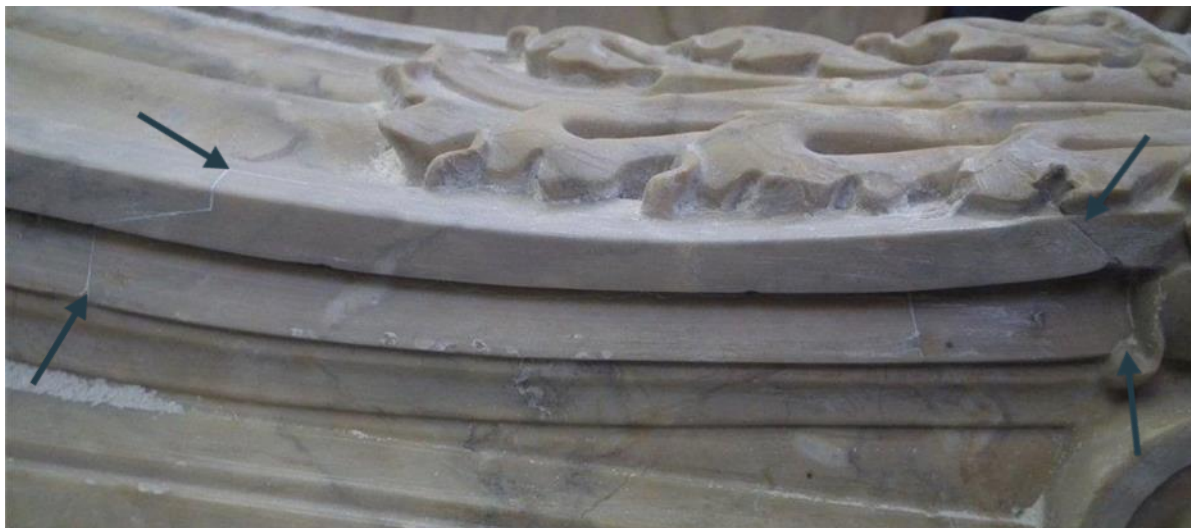
*Plate 9: Detail of the outer edge of a left hand jamb. A new section of repair has been let into the original, the joint line only being visible during cleaning work, as indicated by the arrows on the image above. The process can be seen to illustrate the savings incurred by minimalizing wastage of the block.*

By forming these jamb sections from a number of different pieces, those better coloured and less vented sections could be used, but even this process required some splicing in of repairs, presumably either to hide mistakes in the carving process or blemishes within the marble uncovered as sections of the block were cut away to produce the finished form. The quality of craftsmanship is however very high, for the repairs are often difficult to identify, perhaps the best example, being the repair effected to the outer edge of the left hand jamb of the chimney-piece in the North room, where a particularly complicated section has been let in, worked on some five angles and one curve on the replacement section and an equivalent number within the jamb. The joint line is only just visible (see **detail in Plate 9**) The workshop also took to effecting some economies in the cutting away process. Each of the shells (and the section directly behind, as defined by the strap work border) to the centre top of the Truss of each jamb is deeply undercut and projects beyond the profile of the truss. Rather than use a larger block of marble to form the truss and projecting shell, and then cut a great volume away, the shells and strap work behind have been carved out of separate blocks and then joined by the means of a lug set into a recess, the shell held in place by plaster of Paris.

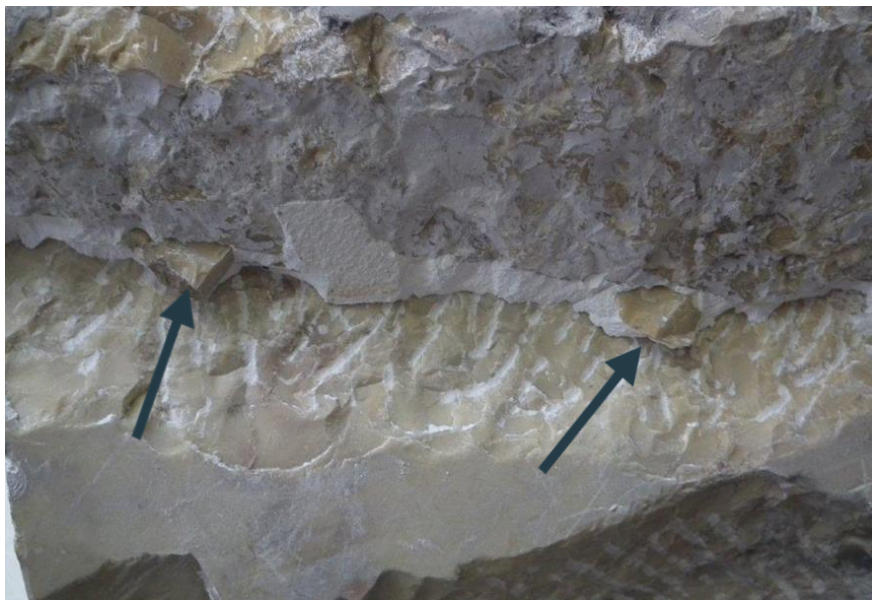
Plate 10: Detail showing how the various sections of marble forming the corner blockings were secured in place. Chippings of Sienna marble, as indicated by the arrows, have been used as an aggregate to re-enforce the plaster of Paris used to hold these elements together. Further re-enforcement was also required in the form of cramps set into holes cut into the top and underside

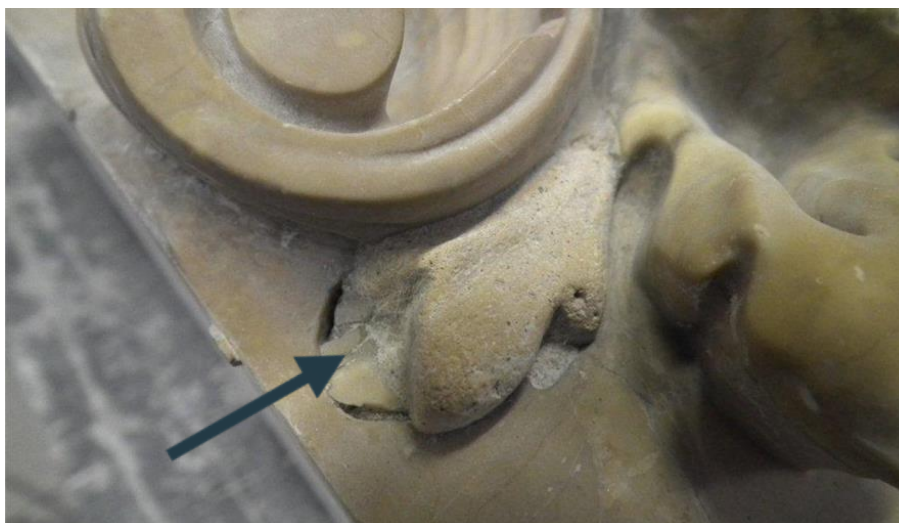
Plate 11: Detail of the tip of an acanthus leaf to the left of centre of one of the friezes. Much of the tip of the leaf has been replaced in composition. This later repair, probably resulting from the added element being dislodged, has been retained as the recess cut into the main body of the frieze, indicates how repair work, required and effected at the time of construction, was secured by letting lugs into recesses cut into the main body. Such holes would originally have been obscured or lost by a much larger leaf projection.
