Late 18th Century London Town House

Some notes on the restoration of the first floor front room chimney piece within a late 18th Century London town house. The chimney piece perhaps attributable to the workshop of the Devall family in Little Portland Street.

Research Report
January 2015

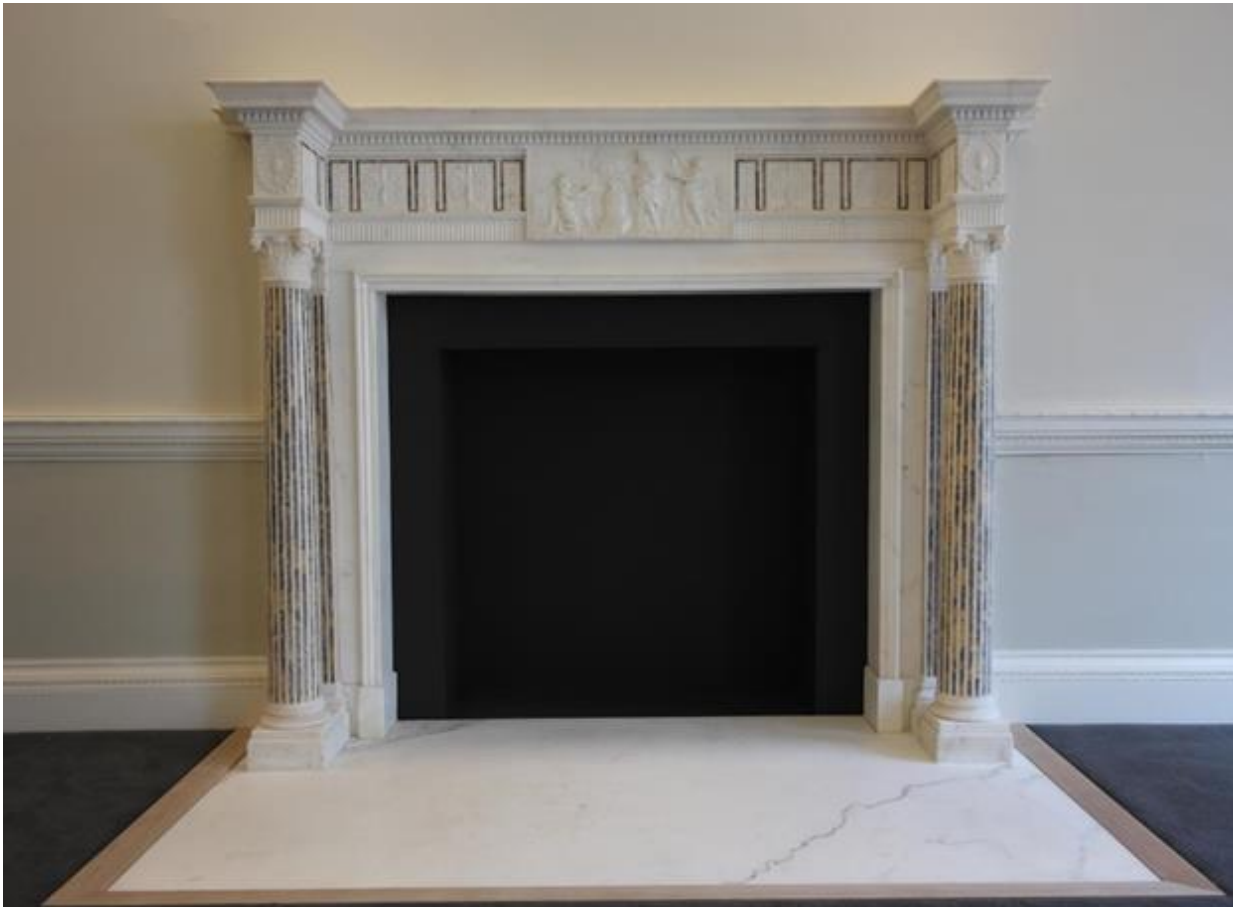
Plate 1: Chimney-piece form after cleaning and restoration work undertaken by Melluish and Davis associates Ltd in 2012. Although much of the surface discolouration has been removed, some deep staining remains and this can perhaps be associated with an earlier cleaning with acids at an unknown date. The central tablet depicts a classical, relief in the antique, Roman, manner, but was probably modelled in terra-cotta by an English sculptor working for the masonry or sculptural workshop that produced the chimney-piece. This process of production at this date required the production of a terra-cotta original, which was then copied in marble. This process accounts for the appearance of closely related centre tablets on chimney-pieces within Encombe House in Dorset.

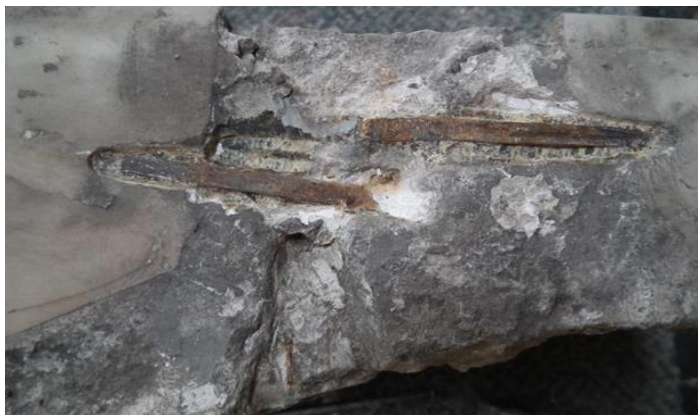
Plate 3: The left hand plinth block taken from above. Substantial iron cramps join the two sections of marble to a central section of Portland stone. To prevent further staining these iron cramps were removed and replaced with copper wire.

Additional work was required removing the iron cramps that retained the elements to the building as well as those holding the various elements forming the chimney-piece together for these will continue to generate staining within the marble in the years ahead. Plate 3

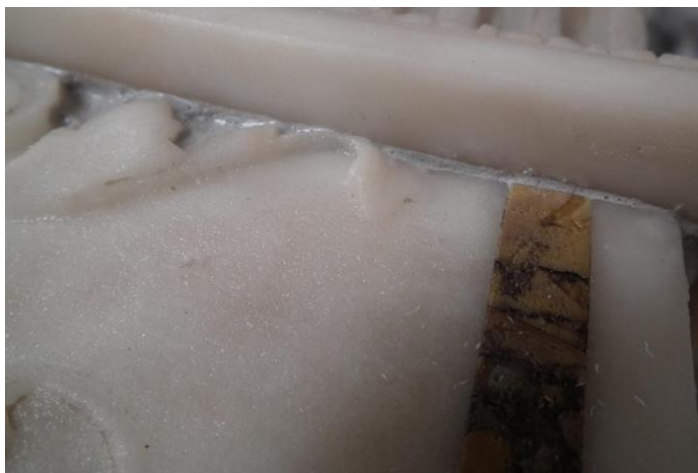
Plate 4: Detail of one of the blockings showing the pitted nature of the surface of the marble ground, the result of acid cleaning in the past, particularly clear in the bottom left hand corner.

Once the rear unseen areas had been cleaned, the exterior facing area of the chimney-piece was lightly cleaned on a test trial basis. It became apparent that at some point in its history the chimney-piece had been painted with a mild acid (perhaps a compound, such as brick clean), which had eaten into the surface of the soft marble. The effects of the use of this compound had a detrimental effect on the marble, causing the surface to roughen and seemingly also strengthening the existing atmospheric discolouration (resulting from smoke from coal fires etc) on the surface and within the marble. Test trials on the depth of this pitting were undertaken and as a result of this a light consolidation of the surface was elected on as the best means of preserving the chimney-piece.

The nature of this acid cleaning is discernible within the following two images which shows the pitting of the surface caused by the application of acid. Plates 4 and 5.

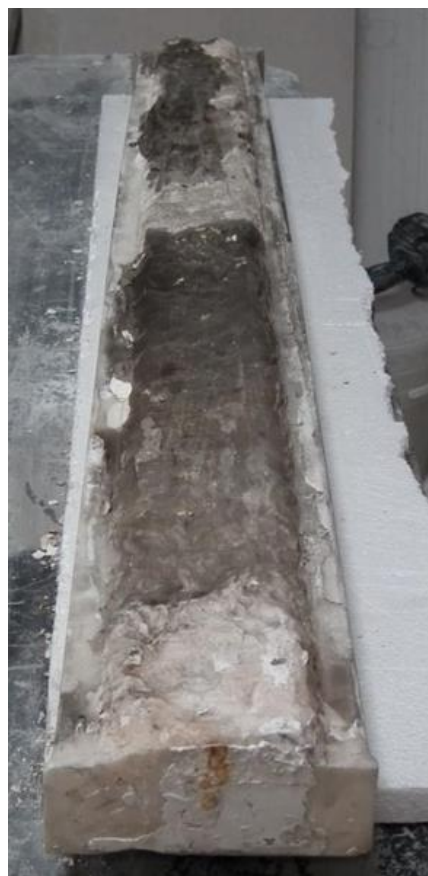
Plate 2: One of the pilaster panels prior to cleaning. The darkened areas indicate that soot from the coal fire had penetrated within the jamb of the chimney-piece. The rust mark visible on the plaster bedding at the base of the pilaster is the residue from the iron cramp used to retain the torus moulding beneath the pilaster to the fabric of the building.

Prior to restoration work existing coal soot was removed from all of the internal sections of the chimney-piece. The depth of this problem was considerable as identified on the image below which shows one of the pilaster panels forming the central section of the jamb. The whiter areas indicate where sections of Portland stone had been used to hold the three elements of marble forming the jamb, the inground (or architrave) the pilaster panel and the outground together. The darker areas indicate where soot from the coal fire had penetrated behind the back of the jamb, perhaps an indication that there was some movement within the fabric of the building whilst real fires were still being used as a means of heating. Plate 2

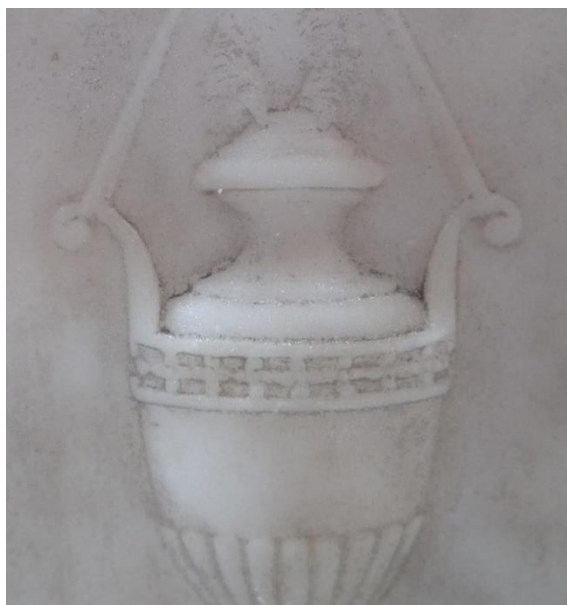
Plate 5: Detail of the incense burner from one of the blockings showing the existing discoloration and surface grime as well as a slight sheen resulting from previous cleaning using a weak acid.

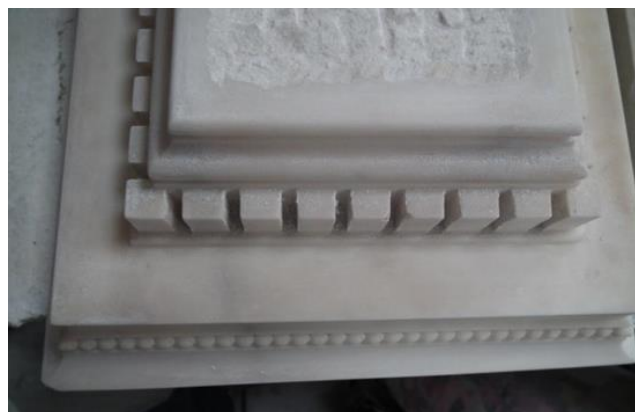
Plate 6: Detail of the right hand end of the cornice showing that the upper edge of the cornice had been damaged and the scotia moulding forming the upper edge of the shelf rubbed in to disguise the damage.

Some additional earlier repairs were also evident, in the astragal moulding at the top of the right hand pilaster panel, and in the rubbed over edges of the plinth blocks (see Plate 10), but particularly noticeable was the re-running of the scotia mould of the left hand cornice end as illustrated below.

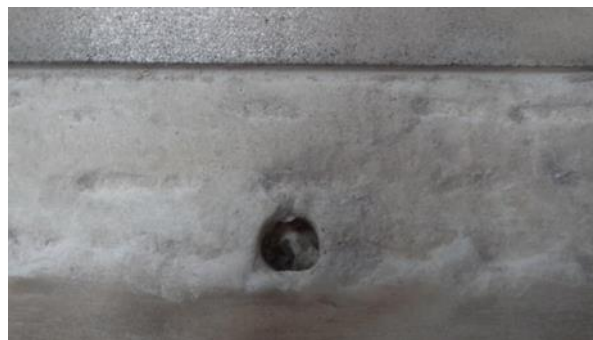
Plate 7: Detail looking down onto the top face of the soffit, showing the hole to the centre of the soffit, almost certainly intended to allow for the introduction of a bolt to support the underside of the soffit, but never introduced. The sheen to the top seen face of the soffit bears comparison to the chiselled unseen side, with the sheen of the former a result of acid cleaning in the past.

A number of interesting features were also uncovered. The soffit, had been drilled to the centre, a process generally introduced, from the mid 18th century, in order to support the underside of the soffit, by the means of a threaded bolt and nut which passed through the soffit and into a large stone liner (or occasionally a wrought iron chimney bar) placed above the soffit and hidden behind the frieze. However in this instance the hole drilled is covered by the fascia above the soffit, thereby preventing any bolt from being attached to any liner, as the fascia is supported to the back with a thin stone liner which covered the whole. Presumably therefore this is a simple Georgian mistake. See Plate 7.

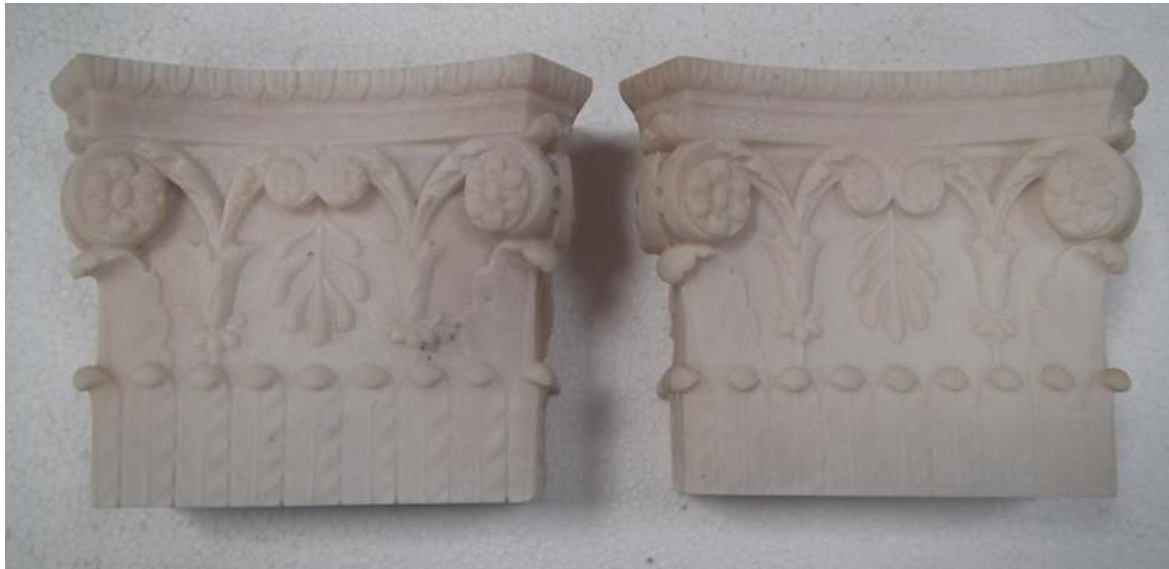
Plate 8: The two composite pilaster capitals showing the variation in finishing of the anthemion ornament, that on the left hand side is more boldly treated.

Similarly comparison of the two composite capitals provide an insight into the finishing of the carving for both capitals have an anthemion ornament to the centre, comparison of one to the other indicate a degree of freedom of completion, with the left hand pilaster having a far bolder anthemion than that on the right. See Plate 8.

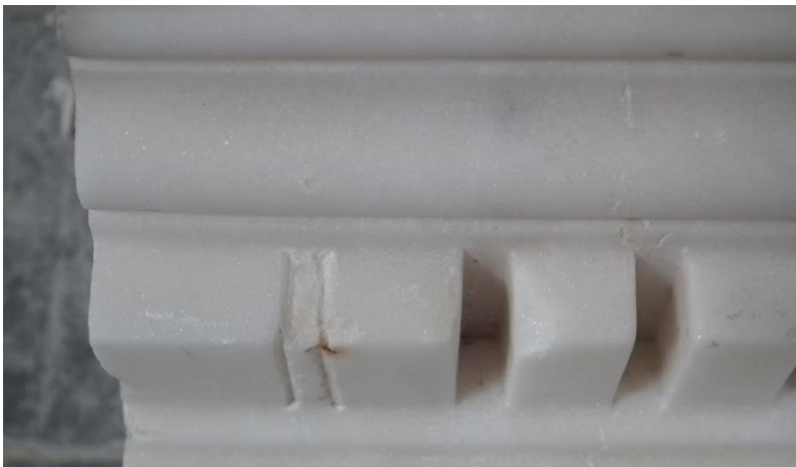
Plate 9: Detail of the right hand cornice, showing scribed cuts in the marble indicating where the next section of the dental course was to be cut out. This was not effected as this section of the cornice was let back behind the plaster face.

Some residual scribe marks were also visible on the right hand cornice return, showing where the next dental was to be cut away, as shown on the following page, Plate 9.

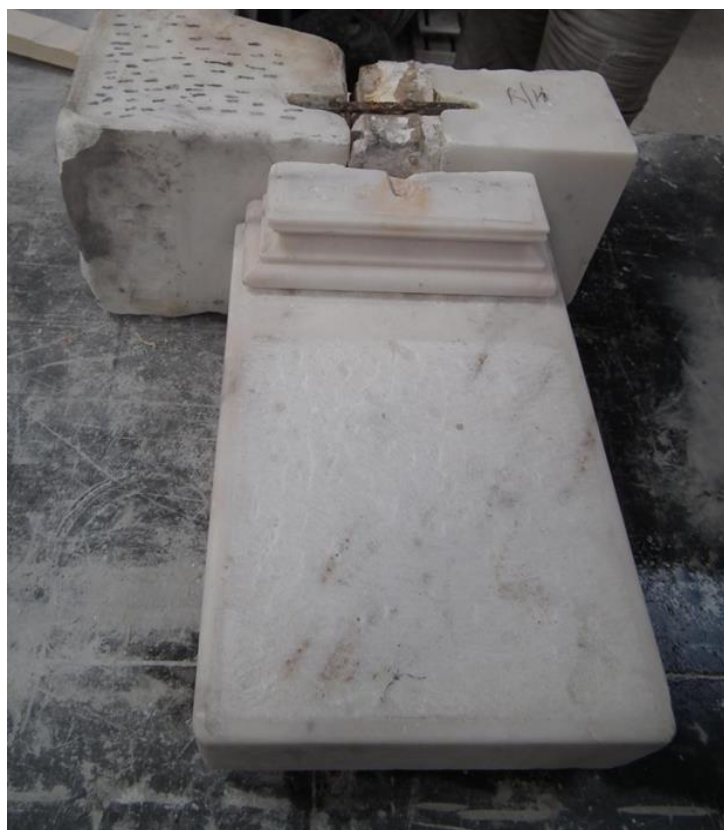
Plate 10: Detail of the right hand plinth block showing the breakdown of the block of marble forming the internal return. Previous repairs have been effected including the addition of an extension now lost. This deteriorated block was reduced in width by 1" and then re-attached with a replacement extension to support the projection of the architrave moulding on the base. This image also illustrates some previous repairs where the chipped or worn edges of the block were rubbed over- a feature not on the outer edge of the facing internal plinth block, but clearly visible to the side of it.

Some more drastic repair work was required for the internal plinth of the right hand jamb, had deteriorated in the past and an extension had been introduced, as identified by the key marks on the face of the internal return. The causes for this appears to have been due to a break down in the structural integrity of this particular piece of marble, perhaps resulting from exposure to excessive heat. The breakdown of this piece of marble is visible in the image below, which shows that the edge and face are showing considerable signs of distress and wear with the surface marble breaking up when touched, even lightly. To resolve this issue an inch section of marble was cut off, the marble, the newly exposed area consolidated and an extension re-attached to provide a projection to support the projection of the architrave at its base. At the same time the original late 18th century iron cramp was removed and replaced with copper for the iron oxide staining can penetrate the marble and is impossible to remove.

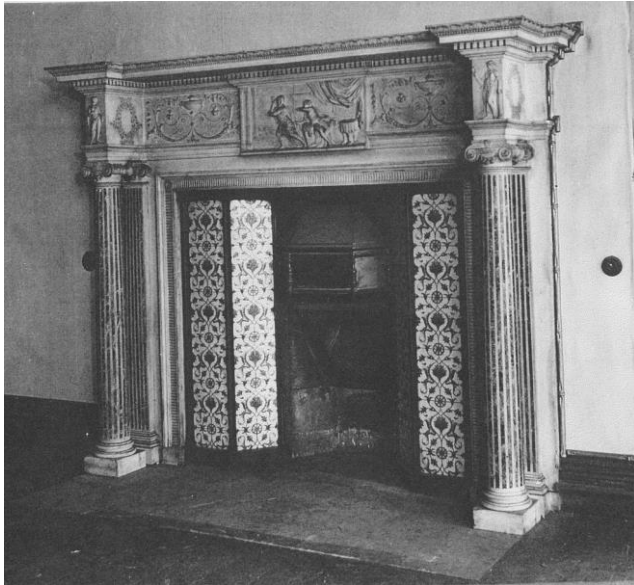
Plate 12: Chimney-piece formerly within the rear west room, 2nd floor of 148 Piccadilly (now demolished). Although of an Corinthian order of architecture, the projecting, inlaid columns and inlaid pilasters generate a similarly substantial blocking projection which bears very strong similarities to the restored chimney-piece although the ornamentation is different. In keeping with several other chimney-pieces within this group the central tablet has a thin border around it. (LMA Image).

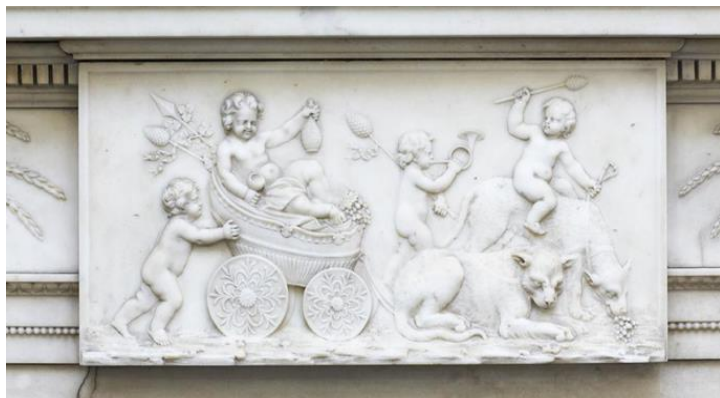
Plate 16: Detail of the central tablet of the chimney-piece in the ground floor rear room. The thin border to the edge is repeated on the first floor chimney-piece, and this feature may be indicative of the Devall family workshop.

It is perhaps interesting to note the repeated use of a similar centre tablet within different chimney-pieces stems from the process of manufacture whereby once a clay model had been created, closely related marble copies could be produced incorporating the same relief on a tablet which could be extended in width and height as required, but with the sculptural size generally remaining the same.. The repeated use of the same inlaid geometric border, or fret as they were generally referred to, together with the repeated carved anthemion leaf ornament is again indicative of the same yard producing a consistently popular motif, but it is also worth noting that many of the chimney-pieces illustrated above also incorporate a thin raised border to the edge of the tablet, a curious feature, rarely seen, and perhaps indicative of the Devall family workshop. It should also be noted that the ground floor chimney-piece within the same house incorporates a similar border as did the chimney-piece in the smaller room of 148 Piccadilly..

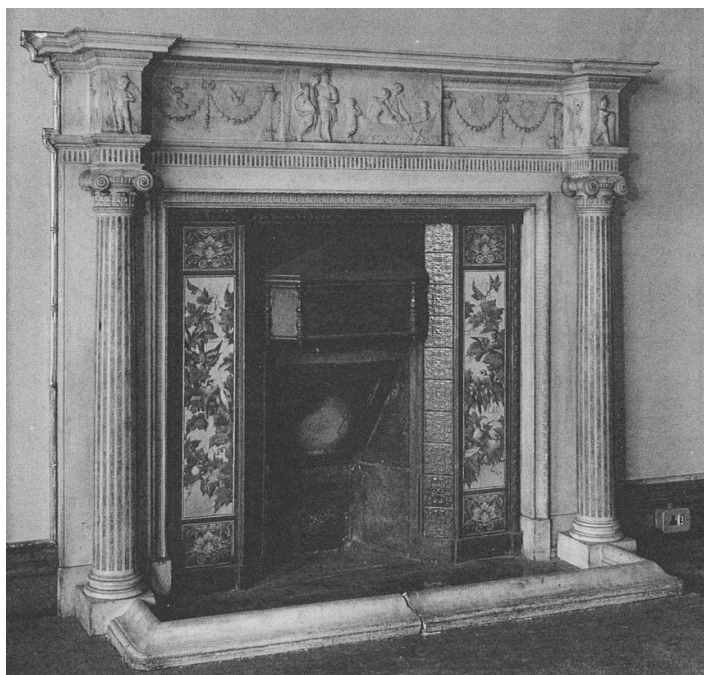
Plate 18: Chimney-piece formerly within the rear east room, 2nd floor of 148 Piccadilly (now demolished). The chimney-piece was of a smaller scale to that illustrated on page 8, an indication that it was fitted into a smaller room. In keeping with several other chimney-pieces within this group the central tablet has a thin border around it. (LMA Image).
